elcome back, in Part 2 the plating and then the second layer of the first deck construction were discussed. The hull beam of a side paddle-wheeler is slim in comparison to that of the first deck since the paddlewheels need to be allowed access to the water yet to increase the functional deck surface area, it also requires the deck to be built around the paddlewheels. The first deck served three main purposes. In the forward third, cargo was stored along with the ground tackle. The middle third housed the upper portion of the engine and its control room. This area also gave access to the paddle-wheels for maintenance and repairs. Interior outboard panels could be removed to give unencumbered access to them. Storage and work related rooms were located in the outboard spaces. I chose to detail the bursar's office, the Captain's quarters and a workroom in detail. These will be viewed and discussed in Part 4. In the abaft third, was the dining salon including a walkway that ran around the outer edge of this deck. The salon was located here since the galley was down one flight of steps. If one looks into the forward area of the dining salon, they will see the banisters and railings for t

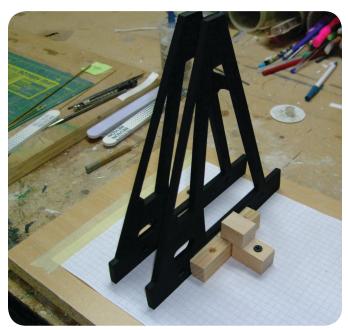
Photo 31. The frames needed to be held by a jig, at the correct angle during the addition of the cross members.

since it would be easier to keep clean in a coal fuel environment, however when modeling anything one must represent what the ship would look like from a distance. The distance tends to diminish the luster of paint. Photo 30 shows some of the painted frame. The frames were then placed into jigs shown in Photo 31, which held them in place at the correct angles while cross members were added to permanently arrange them. Photo 32 shows one of these cross members which, needed, even more, rivets! There were several points requiring these cross members plus a deck was added to the base as can be seen in Photo 32.

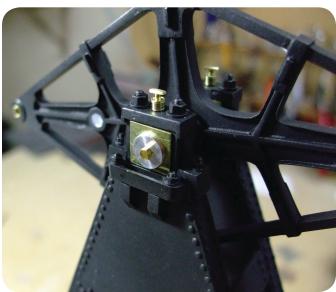
**Photo 41.** The installed bearing for the walking beam with the brass oil reservoir included.

bearing pair differed according to the mounting space. **Photo 40** shows the main crank bearing pair before the brass insert was installed. Photo 41 shows the bearing mounted on the "A" frame holding the walking beam assembly. Note the brass oil lubricant reservoir mounted above the bearing. The oil was distributed by gravity which, demanded constant monitoring to avoid running out. Each of the bearings involved required a constant source of lubricant.

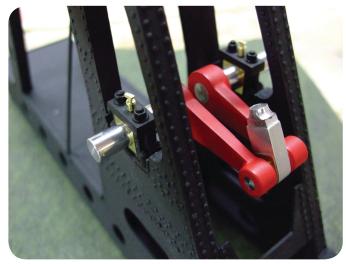
Photo 45. The assembly mounted and ready for the next step.

The main crank was built of styrene as two separate identical halves as is shown in **Photo 42**. The larger end housed the drive shaft for the paddle-wheels. The smaller end held the axel onto which the bearing for the main connecting rod ran which is shown in **Photo 43**. This bearing was made out of Aluminum on my milling machine. **Photos 44** and **45** show the assembly in place on the "A" frame. Note that the drive shaft does not pass through the main crank.

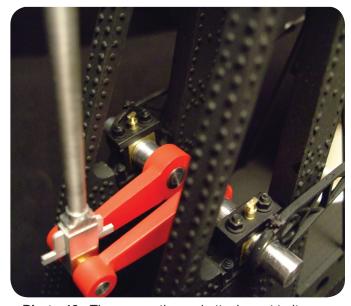
Photo 46. The connecting rod attachment to its bearing at the crank.

The main connecting rod needed to reach 6" to the abaft end of the walking beam bearing from the main crank bearing. This dimension created a problem for me since my lathe bed is at its limits since I needed to use a cross slide to cut a double taper on the connecting rod. The taper is shown in Photo 46. I used aluminum rod as my stock and found that unlike good quality brass the metal does not cut as fluidly. The texture of this metal was sticky which caused vibration at the cutter edge resulting in an unsatisfactory result. Through trial and error, I discovered that a lighter touch and higher turn rates allowed a satisfactory cut. Another issue with the required double cut and the length involved was the flex of the stock away from the cutting edge. Having a follower rest included on the cross slide to prevent the flex caused space limitations so I decided to divide the connecting rod in half so that I could avoid this problem. The other advantage was that I could cut the taper so that the

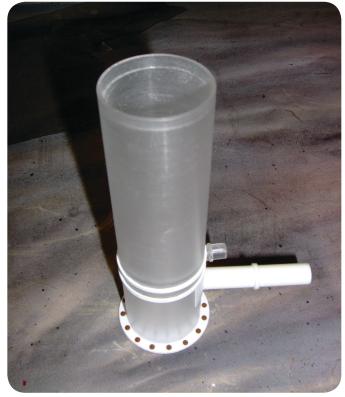
Photo 49. The cylinder assembly before paint.

The business end of the engine is a cylinder with a 9' stroke and a 53" bore for a three-ton piston assembly. Steam at a pressure of 50 pounds per square inch causes the movement of this piston. **Photo 49** shows the beginnings of the build of this part of the engine. I sourced a clear plexiglass tube of the correct diameter. Into which I inserted the steam inlet pipe. This is the white tube found in the lower portion of the cylinder. The smaller clear tube above is included in the delivery of live steam controlled by the valve system. There is a mounting flange at the bottom with cosmetic nuts attached carefully at equal intervals.

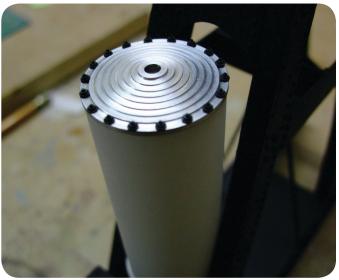
**Photo 52.** The unfinished assembly for the top of the cylinder.

the process of locating the cosmetic nuts once again were sourced from Tichy Train Group. The unfinished result is shown in **Photo 52**. The bolts were later painted with Stainless Steel Polyscale to simulate metal finish.

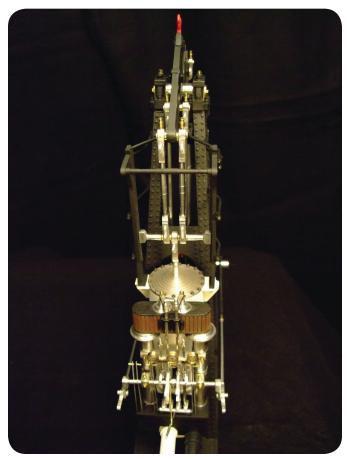
Photo 53. A closer look at the crosshead assembly linking the cylinder to the drive train.

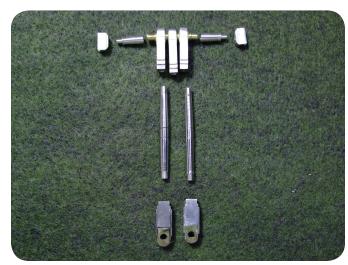
Photo 54. The metal parts required to build the crosshead assembly.

At this stage, the composite "A" frame has been built with the base ready for the installation of the working parts of the engine. Into the frame have been installed the main bearings for the walking beam and the main crank. The walking beam and the main crank have been connected up by the twopiece connecting rod, and finally, the cylinder has been made ready. At this time I needed to build the machinery responsible for the coordination of steam pressure with the motion of the piston and drive train. This included the crosshead which guides the piston connecting rod and links its motion to the forward end of the walking beam. To see this one needs to refer to **Photo 26**. Four bearings were needed, two for the connection to the crosshead and two for the link to the walking beam. A fifth bearing was needed to link the piston connecting rod to the crosshead. A closer look at this assembly can be seen in **Photo 53**. The crosshead assembly slid up and down while simple bearings at each end ran on rails mounted on parallel support structures. These supports were mounted at there bottom to platforms attached to the sides of the cylinder. Also, at the top of these supports were reinforcements designed to guard against deflection. As can be seen in **Photo 53** a single substantive rod ran between mounts on the support structure. This completed the connection between the piston's motion with the walking beam and then the main crank. Photos 54 and 55 show the parts required for the crosshead
